SOLVING THE BRIDGE MAINTENANCE PROBLEM IN BULGARIAN ANALYSIS OF THE OPPORTUNITIES OFFERED BY COMPOSITE MATERIALS

Ilija Ivanchev⁽¹⁾, Dimitar Dimov⁽¹⁾, Andrea Benedetti⁽²⁾, Enrico Mangoni⁽³⁾

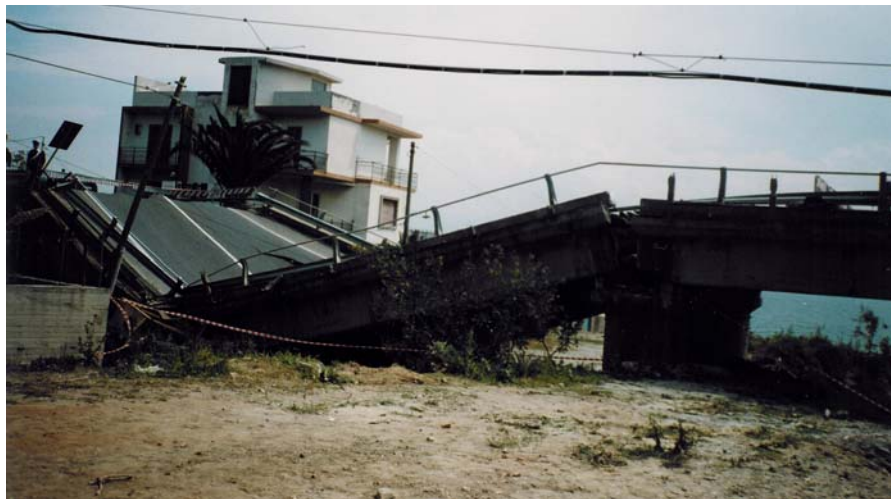
Fig. 5: *Collapse of the Saint Stephan bridge due to pitting corrosion of the main bars*

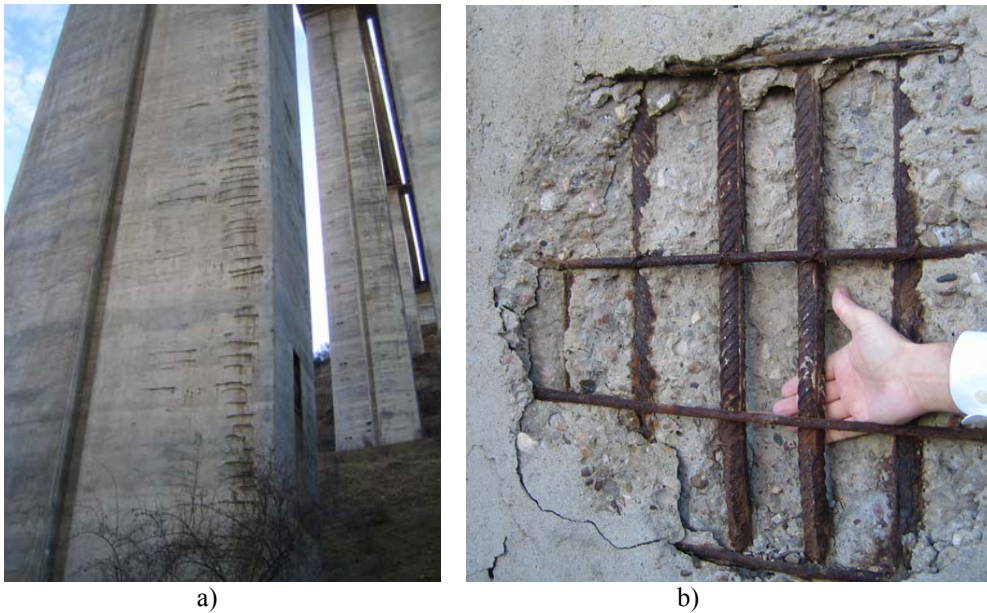
c) In the last years the increase in detachment of concrete cover and reinforcement corrosion was noticed in many supports of the viaducts. This has strong evidence in the “Bebresh” viaduct, where the corrosion affects a large concrete surface in tall pier with height 100-120 m, (fig.9a). The pier dimensions lead huge retrofit problems and special solutions based on innovative techniques could be effective; composite materials like FRP could be employed in order to reduce the quantity of metallic reinforcement exposed to rusting. Similar defects are present in the piers of the long span viaduct in “Hemus - Highway” presenting a steel orthotropic structure whose central span is 162 m, (fig 9b). In the part of the viaduct passing over an old road a severely damaged pier has been already repaired by means of sprayed concrete although this technique cannot stop the evolution of reinforcement corrosion (fig.10).

Fig. 9: View of the corrosion extension in the: a) “Bebresh” viaduct piers; b) piers of the steel structure viaduct with central span of 162 m.

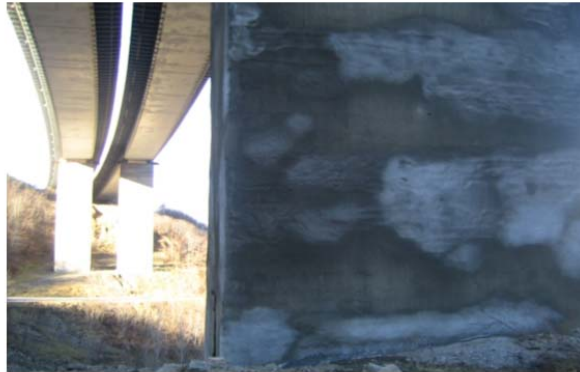
Fig. 10: *Sprayed concrete repair of one pier in the steel structure viaduct near the central 162 m span*

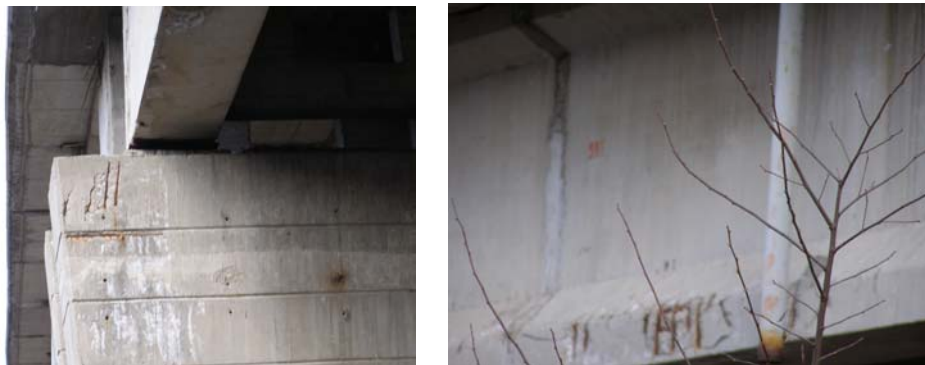
Fig. 11: *Cover detachments showing the start of corrosion in two viaducts in “Trakia-Highway”*

e) Two viaducts in “Trakia-Highway” (side “Varshilata”) were constructed with 40 m beams (fig.11). The beams are composed by joining five prefabricated segments with length ca. 8 m. The segments were produced near Plovdiv and transported to construction site (at a distance ca. 80 km) with lorry. Near an abutment the segments were connected forming the beams with post-tension cables and after that placed with a mounting frame “Sicet” type. 20 years later the beams of the viaduct in show cracks and deflections and the safety margin of the structure is debated and under evaluation. A discussion about the deck substitution is open and also in this case a comparison among classical techniques and innovative ones based on fiber reinforced solutions could promote the selection of an optimal strategy.

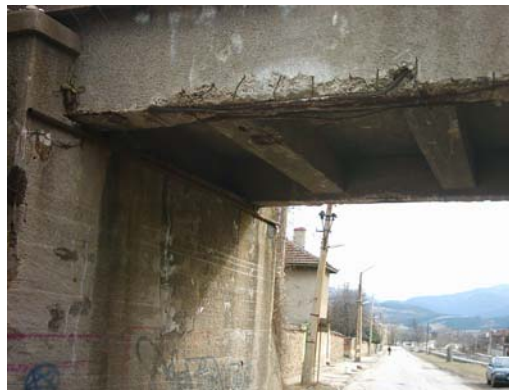
In figure 12 a bridge near Chelopech passing over a road and a river is shown. The main elements present cover detachment and severe rusting of steel reinforcement. The cover was ablated as a consequence of a vehicle impact.

Fig. 12: *Railway bridge in Chelopech showing reinforcement corrosion due to weather exposure after a vehicle impact*

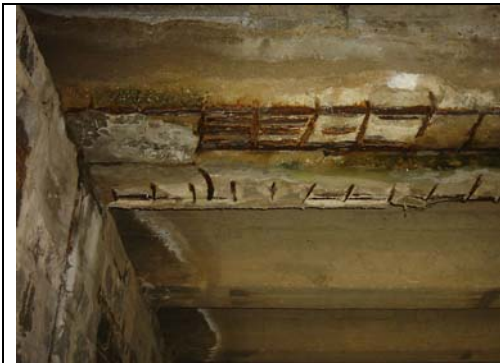
Very similar situation is suffered by the bridge near Mircovo (fig. 13) where the main corrosion agents are the severe atmospheric conditions.

Fig.13:Railway bridge near Mircovo showing heavy rusting of the reinforcement due to cyclic wetting and freeze – thaw.

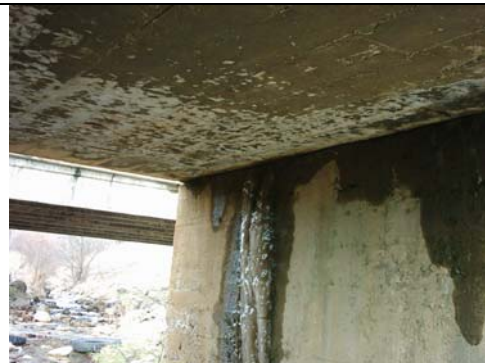
Fig. 14: Water flowing through the dilatation joint at the bridge abutment between the Pirdop and Anton station stops.

In the bridge in between the Pirdop and Anton stations (fig. 14) a significant water flow is passing through the dilatation joint at the right abutment, and this causes corrosion of the vertical structure. Due to salt migration also the bridge deck ceiling is presenting signs of starting corrosion.

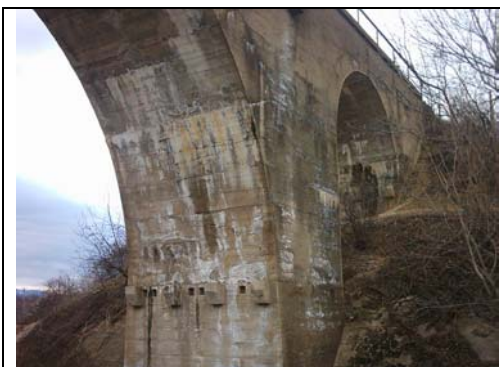
In the figure 15 an arch bridge near Hadzhi Dimovo is shown. The bridge is affected by concrete contamination and weakening as a consequence of the poor water proofing. The arch bridge near Klisura (fig. 16) is in a very similar situation.

Fig. 15. Arch bridge near Hadzhi Dimovo. The lower surface has strong evidence of contamination due to water wetting.

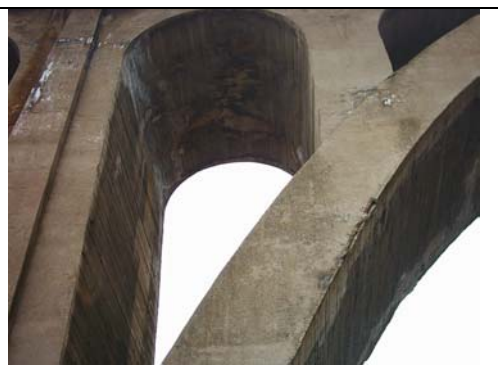
Fig. 16. Bridge near Klisura with evidence of steel rusting on the lower surfaces

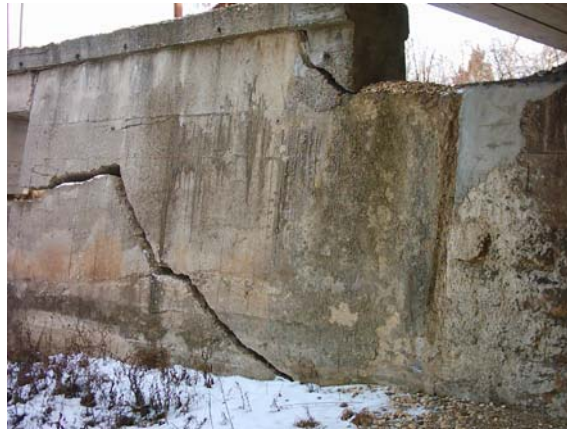
In figure 17 the later containment wall of an arch bridge near Makotzevo is shown. The river side retaining wall has large cracks and leans out due to large rear pressure

Fig. 17. *Large crack in the lateral retaining wall of the bridge near Makotzevo*

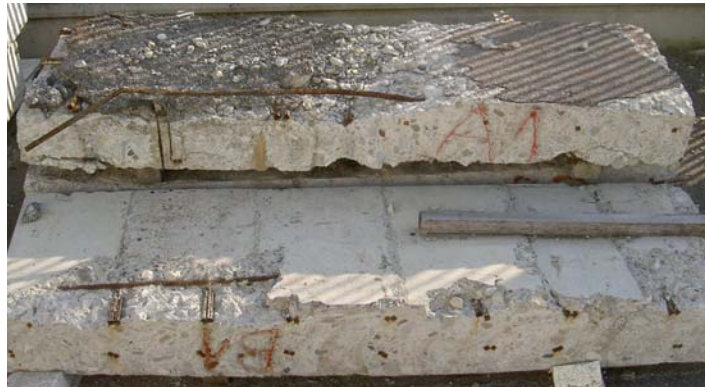
Bars with round and square cross section constitute the steel reinforcement in the longitudinal and transversal direction. This is visible in Fig.20, where a portion of deck slab with spilling and heavy corrosion is shown. On the slab samples, infrared thermography was carried out. This is a non-destructive evaluation technique which uses differences in heat transfer through the structure to reveal the locations of hidden defects. Typical defects that can be located by means of infrared thermography are voids, delaminations, coating defects, such as blistering and subsurface corrosion spots.

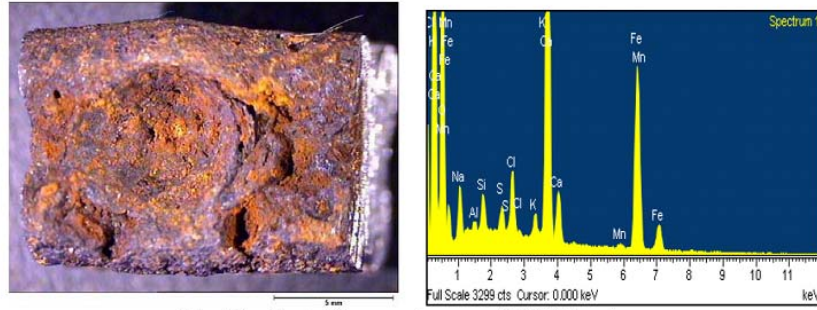
As for the analysis of steel reinforcement (Fig.23), a scanning electron microscope (SEM) equipped with an energy dispersive X-ray (EDX) analyser was employed. In different points of the steel bars, a high percentage of chlorides and corrosion products were observed. The EDX spectrum recorded on the bar cross section is reported in Fig.23, indicating the presence of chlorides and agents of chemical attack (Na, Ca, S).

Fig. 23: Rusted bar specimen and EDX Spectrum

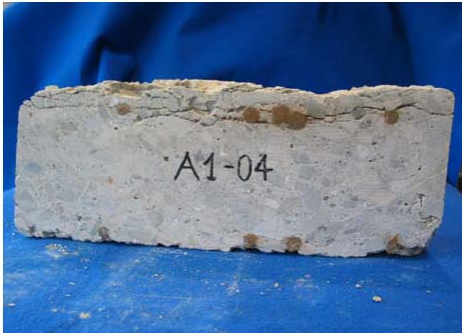
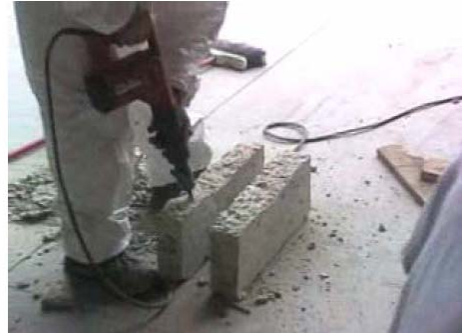
As Fig.24 shows, the typical specimen extracted from the slab exhibited deep cracks at the rebar level; the damaged concrete was then completely removed by means of a needle hammer and the rusted steel rebars were extracted. The concrete restoration was carried out making use of two different mortar qualities. A single component mortar with limited shrinkage and high strength named Sika Monotop-624 A was applied to 12 of the cured specimens. As certified by the technical notes of the producer, the 28-day average strength of this mortar is around 60 MPa. A standard mortar with 3 parts of mixed 325 K cement, 2 parts of sand and 1 part of acrylic emulsion in water dispersion was applied to 12 of the cured specimens. The average 28-day concrete cylindrical strength was estimated around 32 MPa.

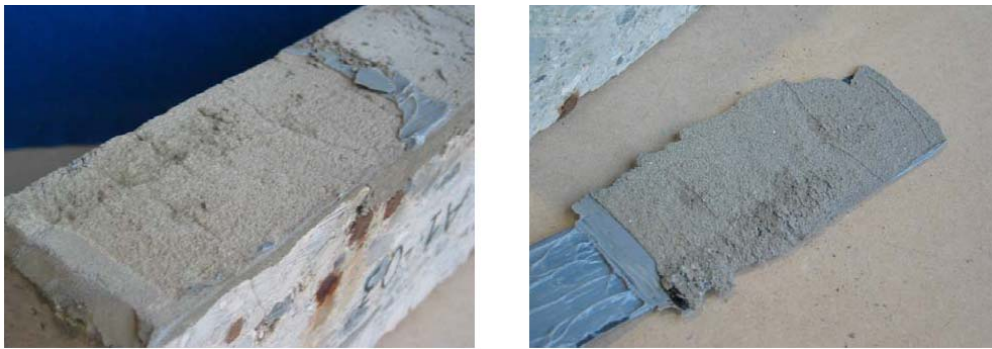
The performed bond tests pointed out very interesting results. Superficial debonding (SD) due to the detachment of the FRP strip from the concrete support (Fig.28) and deep debonding (DD) due to shear failure within the original concrete (Fig.29) were observed during the bond tests of the restored concrete joints executed at the upper side of the slab. This last bond failure mode was much less frequent than the previous one. On the other hand, during the bond tests of the joints executed at the lower side of the slab, superficial

Fig. 28: *Debonding by thin topping material shear failure*

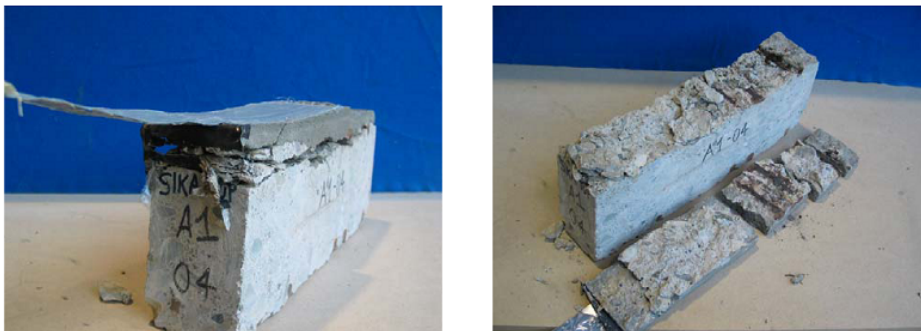
Fig. 29: *Debonding by deep original concrete shear crushing failure*

In Figs. 30.a and 30.b, the obtained ratios of the experimental versus analytical resistances are reported for the bond tests performed on the upper side of the slab, respectively when the Sika Monotop 624 A mortar and the standard mortar are employed for restoration. For both cases, an average efficiency factor very close to 1 was found (0.98 and 0.93 respectively), despite 4 of the 12 bond tests underwent failure with a deep debonding failure mode (Fig. 29).

In this case, a shear failure occurred within the original concrete support, as attested by the measured value of the bond forces. The retrofit joints exhibit bond forces at failure that are in good agreement with the theoretical previsions i.e. the loss of joint efficiency due to the concrete restoration is not appreciable.
