## RETROFITTING OF INDUSTRIAL STRUCTURE

Camillo Nuti

Ivo Vanzi

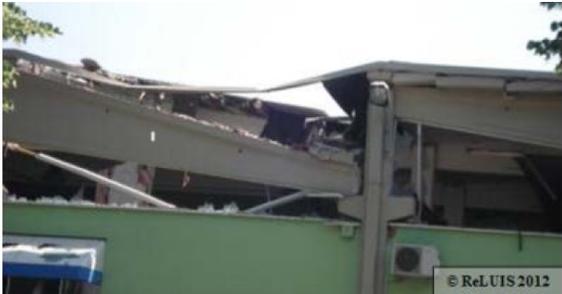
In case of absence of seismic design the following short descriptions can be given while for larger descriptions are given in the references. Type a) failures are essentially due to fact that the connections between beams and columns were just left to friction (the same usually holded among horizontal closure elements (which constituted the roof) and supporting beams. In many cases there were dowel of insufficient resistance. Usually the dowel caused failure of the cover losing any resistance to horizontal actions.

**Fig. 3 (left) failure due to loss of support (friction only) [Prtezione Civile 2012]; (right) failure of cover due to dowel action [Fishinger 2014]**

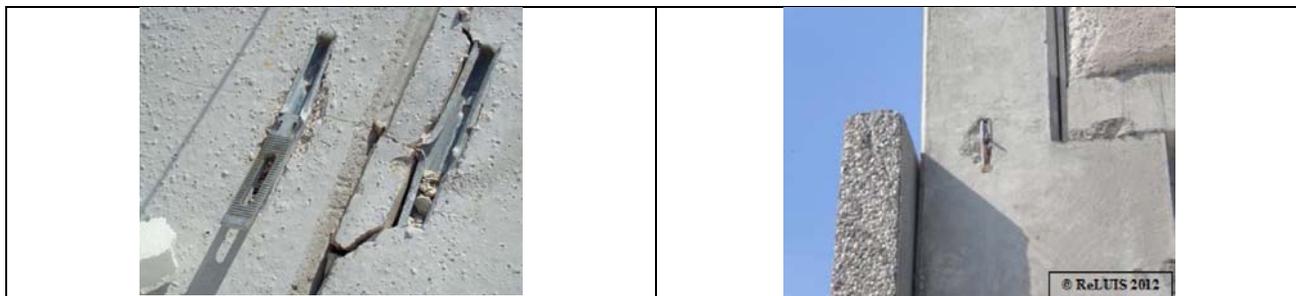
Type b) failure have been observed in case of precast vertical and horizontal panels as well as in case of masonry claddings, these latter usually utilized in the older buildings. For all type of failure, with the exception of out of plane masonry panel failure usually due to total lack of connection, the main cause of damage/failure was the excessive deformability of the structures which caused the panels and the connections to act as horizontal resisting systems. Connections were not able to have a sufficient ductility and failed in a brittle manner.

**Fig. 4 - Failure of hammer – head, Emilia Earthquake. Left [Fishinger 2014], right [ Protezione Civile 2012]**

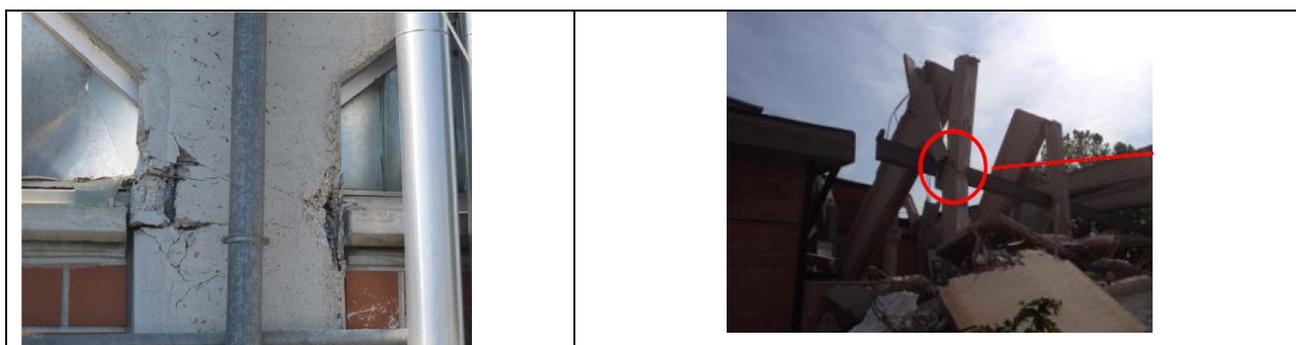
Type c) failure and damages happened in columns, usually having socket foundations. They often lost the vertical asset due to plastic rotation at the base for insufficient resistance of the socket, or yielding of the column. In various cases the excessive spacing of stirrups caused buckling of longitudinal reinforcements. The industrial pavement in concrete represented sometimes an unexpected constraint with negative consequences for excessive shear or bending or stiffness of the column. In other cases the constraint of the pavement had a positive contribution. The hammering effect of the infill cladding as well as the horizontal elements have been causes of many damages and failures. The presence of an horizontal continuous windows at the top of the cladding, was the cause of shear failure in many situations.

**Fig. 5 Short column effect due to strip windows at cladding top and to the restraint of the rail of the crane [Protezione Civile 2012]**

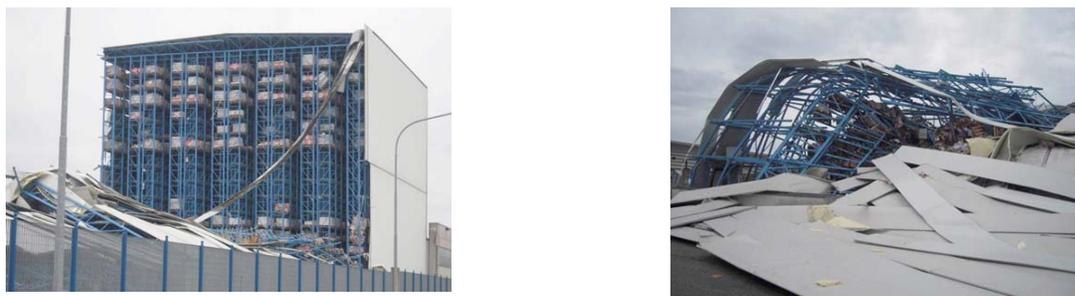
Type d) represented a novelty for the large consequences in terms of induced industrial building failure or for the fact that they put out of use the buildings which were also difficult to be surveyed and repaired. The lost of the content was also a major problem due to the high value (for example in case of Parmigiano Cheese).

**Fig. 6 – Industrial building failure due to interior racks: left failure of the building due to the movement of racks (left), failure of the racks and of the building (right).**

Type h) happened due to the fact that the content was not considered in structural design as well as for old structures Fig. 6.

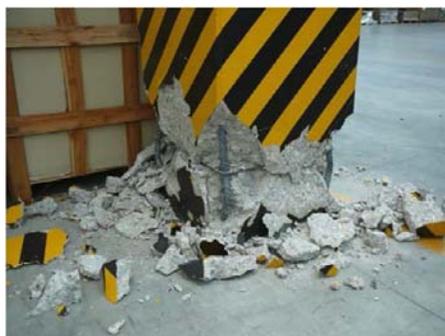
Type g) failures were usually due to some errors in modelling or in construction details. A typical one is the absence of gap between concrete floor and columns. This fact reduced column free height and forced the plastic hinge to concentrate just above the floor, far from the attachment at the footing. In this latter position stirrups were probably placed at small spacing to comply with ductility design details for plastic hinge zones. The position above the floor were not considered a critical one, therefore stirrup spacing was large and buckling of compressed bar happened.

Type i) failures happened even in case of seismic design for the excessive displacement of the structure or for poor details Fig. 7.

**Fig. 7 – (Left) compressed bar buckling due to plastic hinging over the concrete floor, for loose stirrups [ Protezione Civile 2012]; (right) failure of the zone around the plug for excessive deformation and insufficient stirrups in the support and cover in the beam [Fishinger 2014].**
