Dott. Stamatios Stathopoulos – DOMI S.A.
“Inspection of Euripus cable-stayed bridge”

INSPECTION OF EURIPUS CABLE-STAYED BRIDGE

Euripus road bridge, located ~80 km north of Athens, is the first Greek cable-stayed bridge. It consists of two approach viaducts of conventional type with prefabricated prestressed beams of length 143.50 and 156.00 m respectively and one central cable-stayed section of three spans 90–215–90 m, constructed by the cantilever method (cast in situ concrete). The approach viaducts rest by elastomeric bearings on twin frame piers, founded on the rocky subsoil of the area; on the contrary, at the central bridge, the cable-stayed deck is monolithically connected to the twin frame pylons, which are founded on piles. The bridge was constructed between 1987 and 1993. Its design included important pioneer elements for that period, the boldest of which was the design of the deck as a solid slab, of a constant thickness 0.45 m, hanged at its edges per 5.90 m, prestressed generally in the transverse direction and locally in the longitudinal one. On the other hand, the cables were old-type, with parallel strands within HDPE pipes, protected with cement grout. From 1993

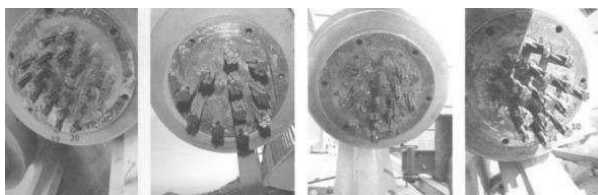
Figure 7: Characteristic figures of bottom anchorage heads

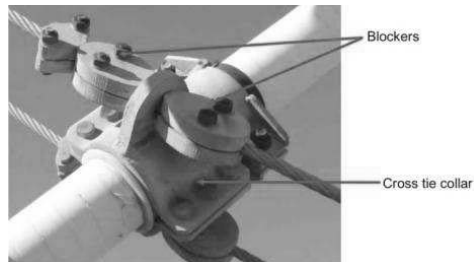
Figure 10: Special device at the nodes between cross ties and stay cables

Due to the geometrical arrangement of the stay cables and the cross ties, an out-of-straightness of the latter presented at each node, which has caused a transverse local force of small size but able to press the strands on the rings; this pressure, systematically increased by the action of the transverse winds, led to the break of some wires of the strands.

Although the problem did not pose any danger for a total strand failure, the removal of the cross ties and the replacement of the strands have been considered as prudent; the detail of the node has been kept as it was, only with an essential improvement of the curvature of the lips of the rings.

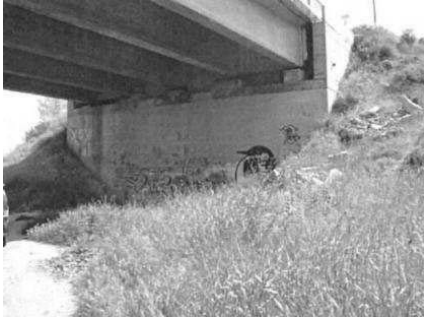
Figure A1: Abutment A0 – General view and vertical crack at the whole height

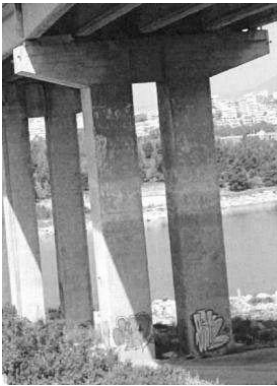
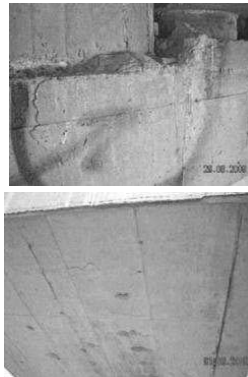
Figure A2: Typical pier of the viaducts, delaminations at an area $\sim 50 \cdot 50\text{cm}^2$ under the beam bearing at pier M1 and delaminations and visible reinforcement at the bottom part of the girder of pier M3

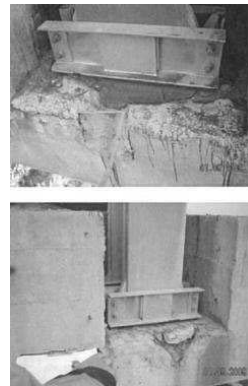
Figure A3: Pier M4 – General view and concrete damages at the base of the hold-down devices

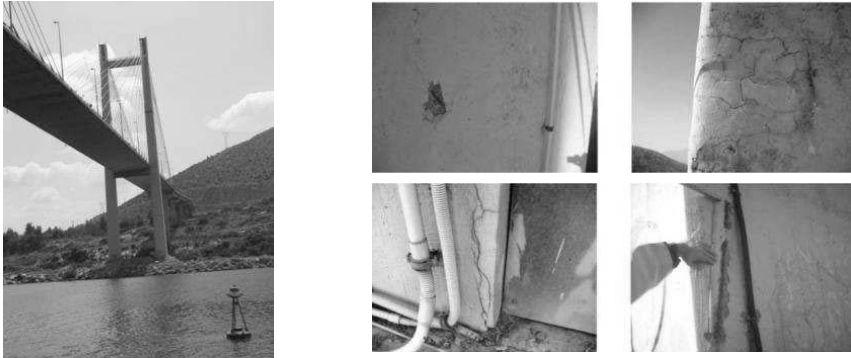
Figure A4 : Pylon M5 – General view and concrete damages e.g. delamination with corroded reinforcement at the column, cracks at previous concrete repairs, delamination at the area of the manhole of the pylon, visible corroded reinforcement at the base of the pylon

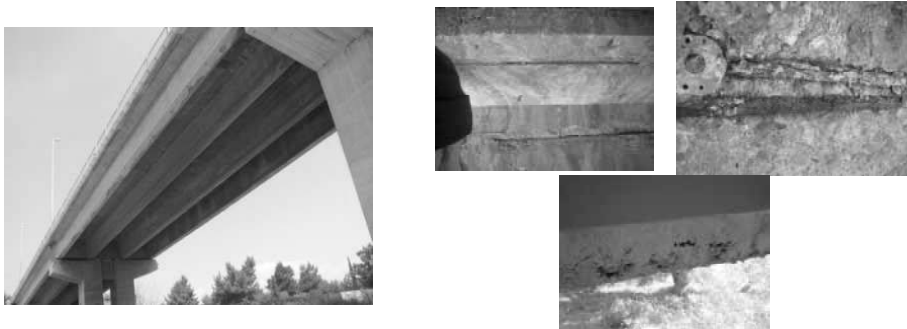
- Surface concrete damages have been systematically presented at the points of the gutters, where due to the bad construction details, the rain has been strongly licking the concrete. This damage has been more intense at the approach viaducts due to the complex geometry of the cross-section and smoother at the central bridge, where due to the simple geometry the discharge of the water was easier.

Figure A5 : Typical deck of the approach viaducts and visible corroded reinforcement at the bottom flange of the deck beams, concrete corrosion at the area adjacent to gutters and , porous at the bottom flange of the prefabricated beam

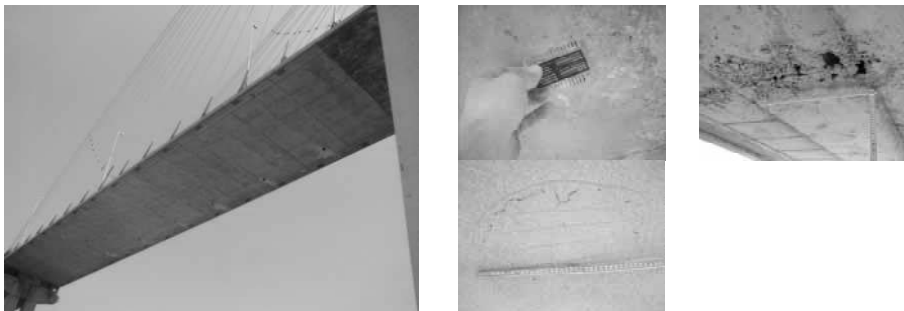
Figure A6 : Deck slab of central bridge, very small cracks of ~0.10 mm width at the bottom surface of the slab, locally large porous and delamination at the bottom surface of the slab

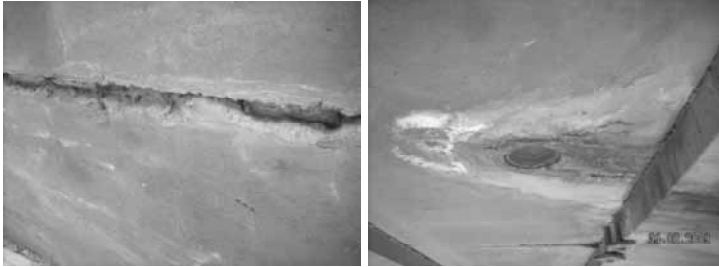
- The pre-slabs of the deck of the approach viaducts have presented unexpected damages at a large extent, namely longitudinal and transverse cracks, crumbles of concrete at the pre-slabs joints and locally large deflections.

Figure A7 : Damages at the joint between two pre-slabs and moisture at the area adjacent to gutter

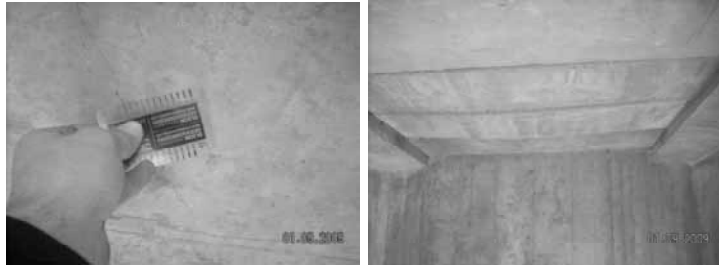
Figure A8: Very small crack and visible deflection at the pre-slabs

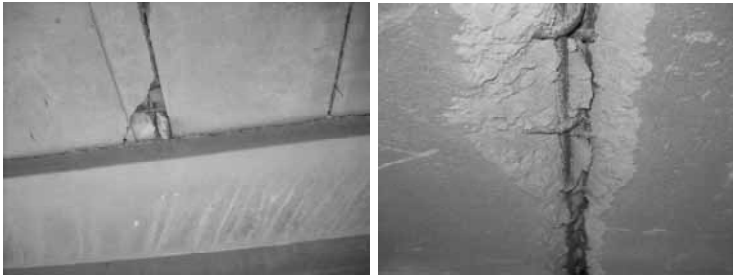
Figure A9: Fracture of pre-slab edges and visible pre-slab reinforcement, failed repair

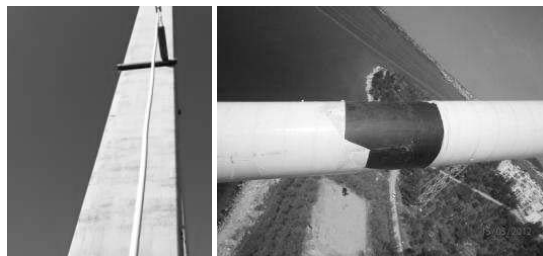
Figure A10 : Waving of the cable pipe (not the strands) due probably to loose hanging during construction, minor damage of the protection tape; the 44% of the stays presented such small damages of length up to 50cm

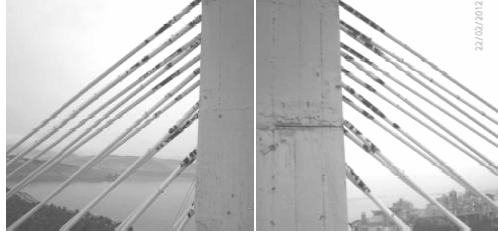
Figure A11 : Damages of the protection painting of the stay cables near the pylons; at this area no special protection tape has been applied (due to the inability of the wrapping machine) and it has been replaced by painting, which has been destroyed over the time.

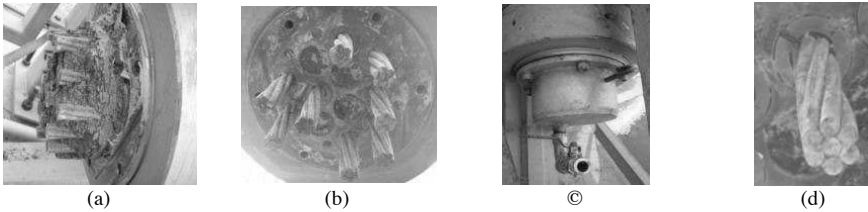
Figure A13 : Stays bottom head (a) after the opening of the head, (b) after the cautious removal of the cement grout, (c) re-position of the cover with the special inlet of wax injection and (d) detail of strand and wedges

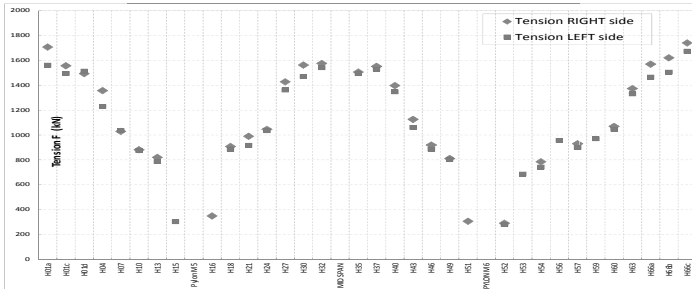
The right stays systematically show increased forces in comparison to the left ones (in average 1.6%) with a maximum deviation in stay 1a (back stay) of ~150 kN, namely ~10%. The difference is due to the overstressing of this specific stay, already known from the construction period, which had also led to a horizontal displacement of the head of the pylon M5R per ~20 mm towards pier M4.

Figure A14 : Comparison of stays tension between the left and right cable plane
