DYNAMIC INVESTIGATION OF THE PONTE TARO BRIDGE IN PARMA

Abstract

masonry bridge, dynamic identification, frequency shift, damage detection, masonry properties

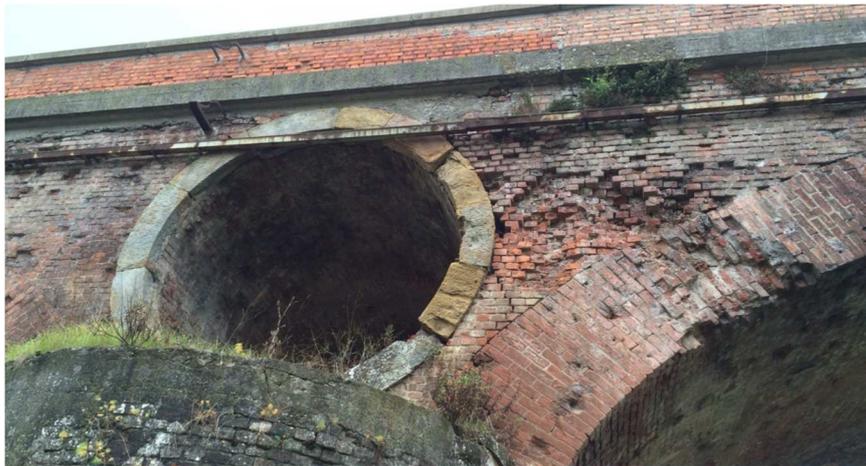
Figure 3 – View of the masonry damage in the spandrel wall

The Taro bridge has many localized damages in the masonry structure and in the stones protecting the parapets and the edges of the flooding holes. Some brick textures are weathered by exposition to salt or river flooding, some mortar courses have been repeatedly repointed, and even the foundations have been stabilized by pouring concrete and cyclops stones around some piers. In the following some pictures of the damage evidences are presented (LGE, 2016, figures 3 and 4).

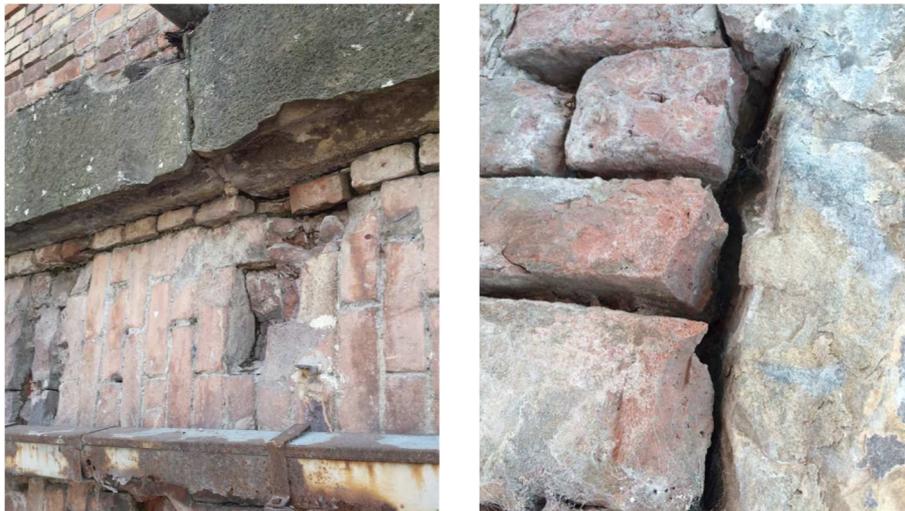
Figure 4 – View of the damaged masonry at the drainage pipe and on a stone cornice

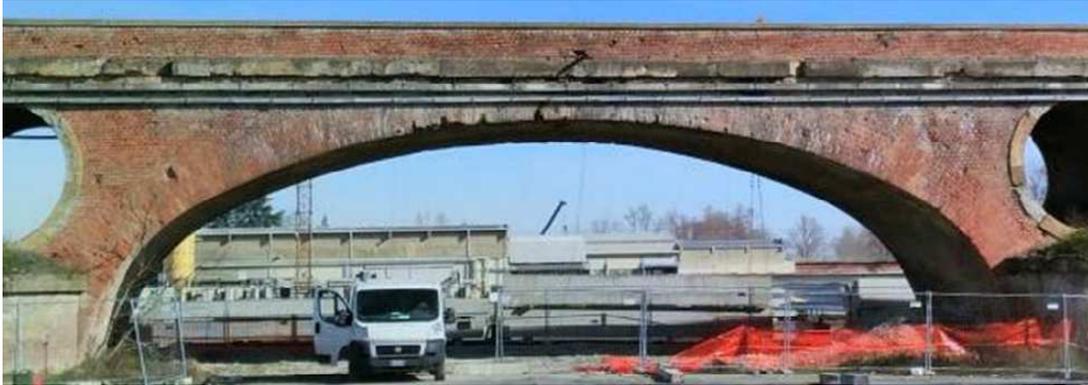
Figure 5 – Typical span of the Taro bridge

The bridge has a total width of 8.0 m and is composed of 20 spans of 28.0 m pier to pier distance; the arch span is 24 m and its sag 6.70 m. The arch line is composed of three circular segments of different opening and radius in order to produce a nearly elliptic geometry. The external arch segments have a radius of 4,7 m and an opening of 60° , while the central one has an opening of 60° but a radius of 19,7 m. In the following figure 5 one span of the bridge is shown in detail.

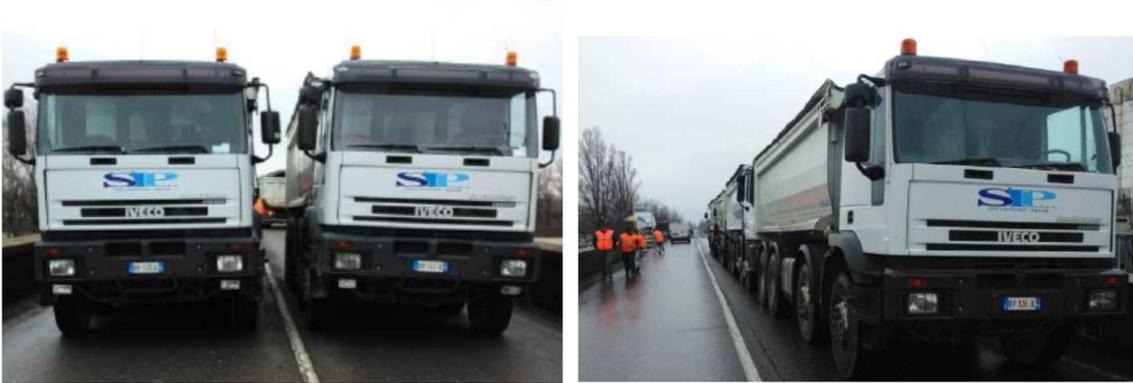
Fig. 12 – View of the trucks over the bridge road for the static tests

The static loading has been executed by using three different configurations of four full weight trucks, as depicted in the following figure 11. All the trucks weighted approximately 302 kN.

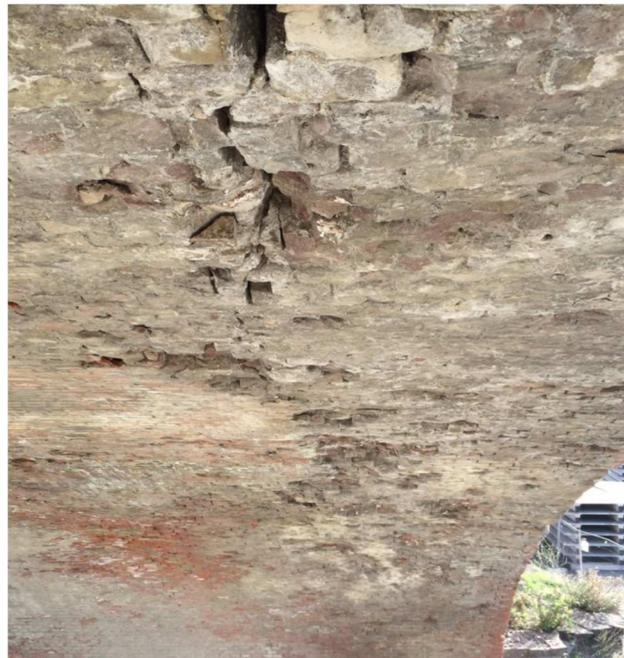
Figure 19 – View of the masonry damage and salt spread at the arch intrados

This frequency decay is linked with the damage detected in the lower face of the fifth arch, which is characterized by a huge crack. Since the arch probably has been repaired after the II World War, it is possible that the joining surface has opened during the subsequent use for reasons of cyclic loading or mortar deterioration caused by weathering.
